Intelligent Manual Call Point  
Installation Guide

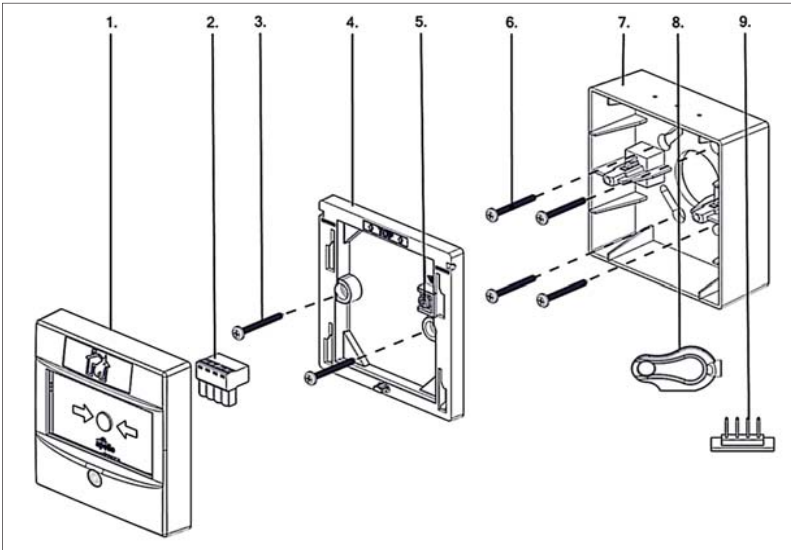
Product Overview

| | Item | Qty. | | Item | Qty. |
| 1. | Head unit | 1 | 6. | Fixing screws (NOT SUPPLIED) | N/A |
| 2. | Connector block | 1 | | | |
| 3. | Fixing screws | 2 | 7. | Backbox | 1 |
| 4. | Mounting bracket | 1 | 8. | Reset key | 1 |
| 5. | Earth Continuity Terminal | 1 | 9. | Continuity link | 1 |

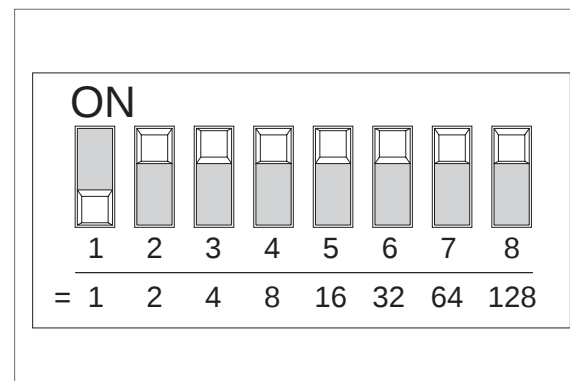
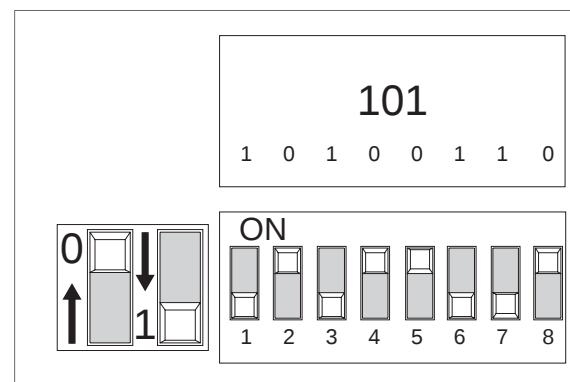
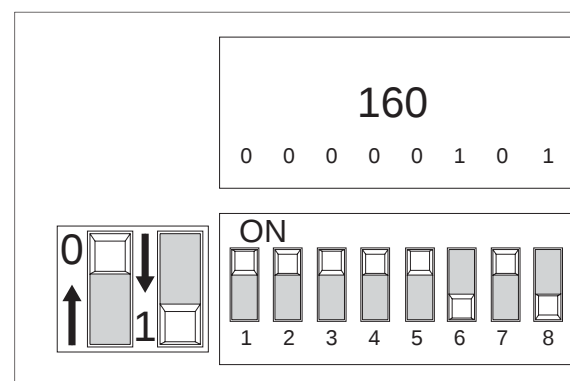
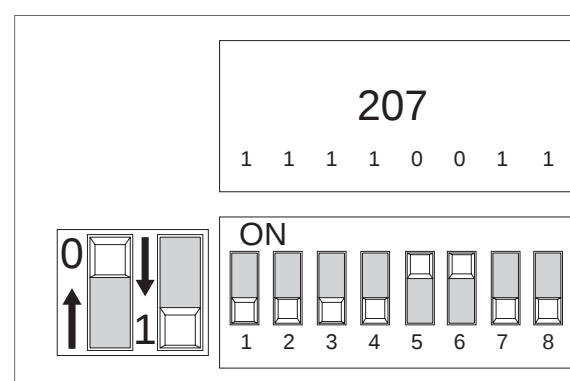
## Address Setting Examples

⚠ The 8th segment must be in set to "0" for Discovery or XP95 operation

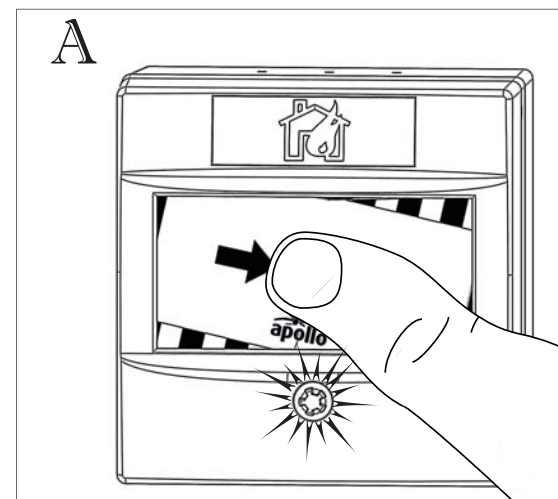
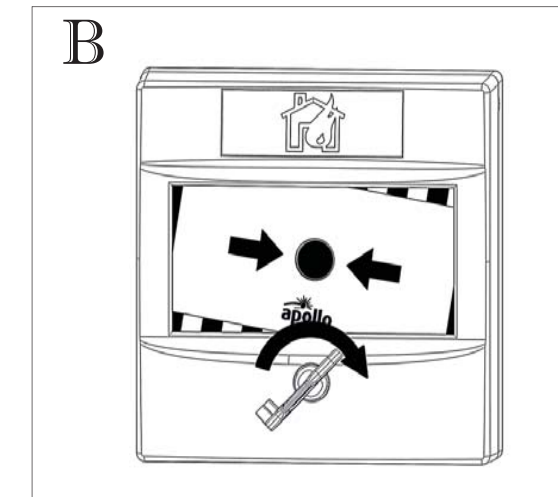
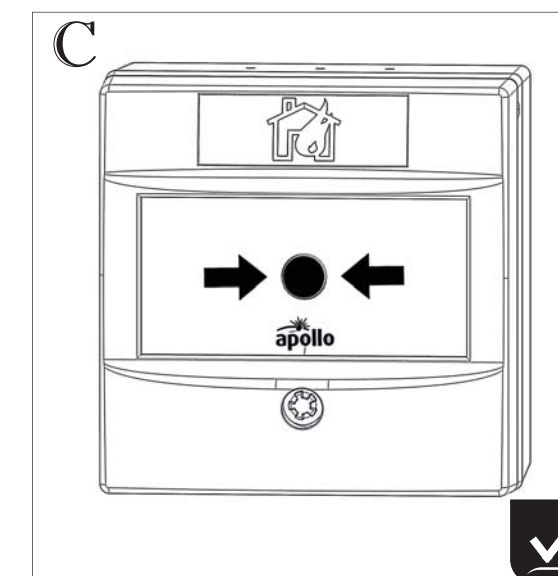
## Testing

Illuminated red (under CIE control) when call point is operated.  
Illuminated yellow when short-circuit isolator has operated (version with integrated isolator). Flashing yellow when a fault has occurred.  
Flashing green when MCP is polled by the control panel (Discovery & Soteria only).
